Tech Tips

Problem: Access Denied Card: 00000000

Product: Velocity

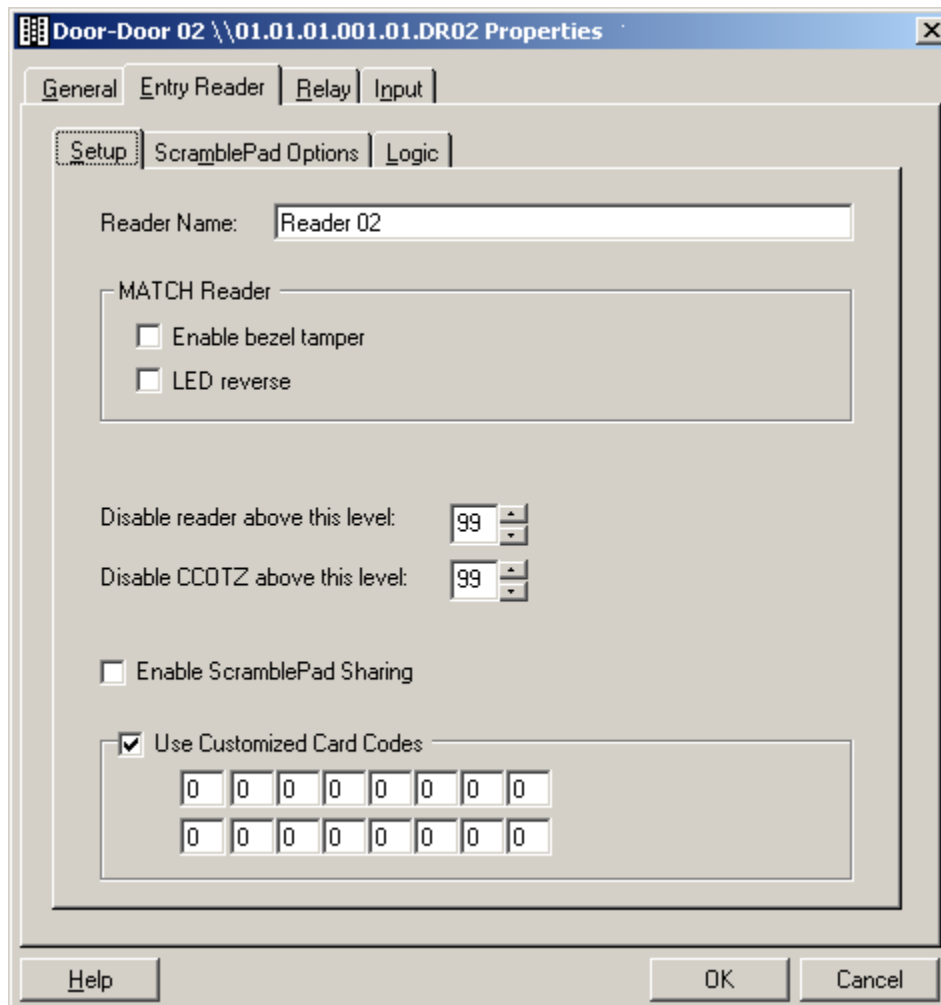
Explanation: Access Denied Card: 00000000 indicates that the match code generated from the card is reporting as eight zeros (00000000). Invalid code reporting must be enabled at the controller in order for the match code to be displayed (Controller Properties > Reporting > Invalid Codes), otherwise the message will be displayed as “Access Denied Card” with no match code shown.

This behavior is a known issue with the 7.4.02 CCM firmware update (see release notes for CCM 7.4.06). The “Use Customized Card Codes” feature was being enabled when it should be disabled by default.

Trouble shooting steps: For Velocity 3.0 and older; Edit the properties of each affected reader and uncheck the “Use Customized Card Codes” check box located towards the bottom of the “General” tab.
